**Review of Aeronautical Fatigue**  
**Investigations in Switzerland**

*36<sup>th</sup> Conference & 30<sup>th</sup> Symposium*  
*of the International Committee on Aeronautical Fatigue and*  
*Structural Integrity*

## Document: ZAV-KOR2019-001

### 4.3 Junkers Ju-52/3m from JU-AIR

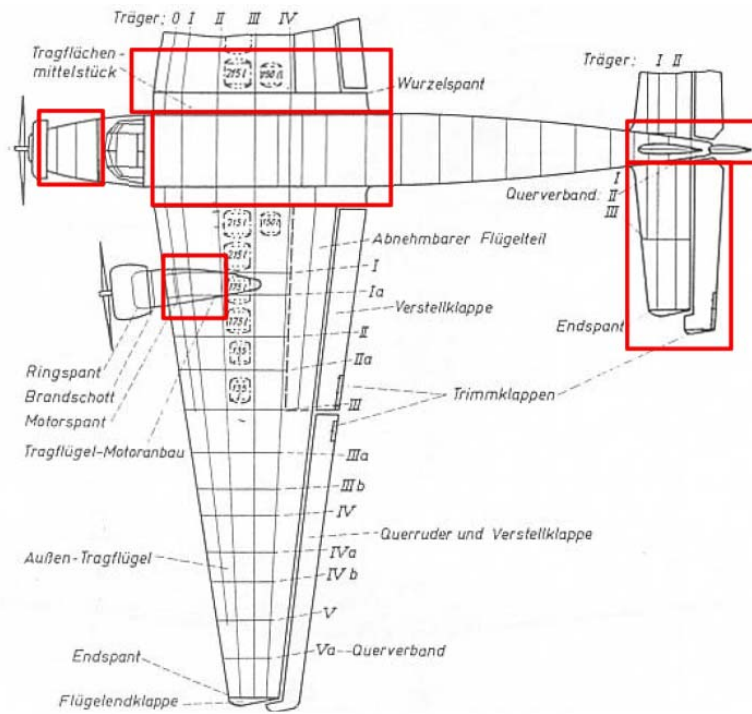
Due to the collected information, the FOCA identified fatigue critical locations which were the basis for the work done during phase II. The report showed the following elements as potentially critical with respect to material fatigue (see also Figure 8):

- four truss wing spars with the diagonal web (tube design)
- Horizontal tail single trim spindle for elevator control
- Horizontal and vertical tail spars and attachment points
- fuselage frames and spars
- control surface connections
- engine mounts and connections to fuselage or wing

Figure 8 Locations of critical elements on the Ju-52/3m according to FOCA

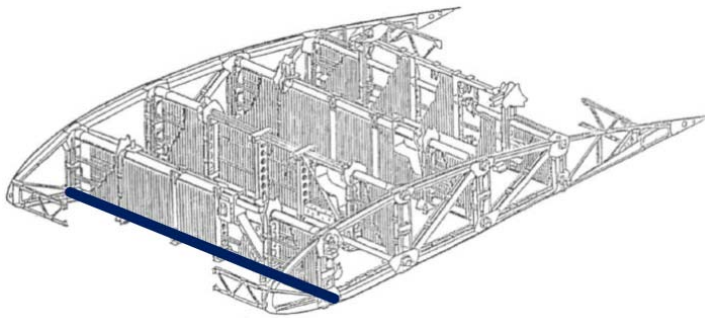
Besides the required structural analyses of the wing spars, a cracked spar on the HB-HOT in winter 2016/2017 led to further investigations regarding the wing structure. The cracked spar was found on the lower, forward spar of the central wing box (see Figure 4 and 5).

Figure 9 Blue line shows the lower, forward spar of the central wing box

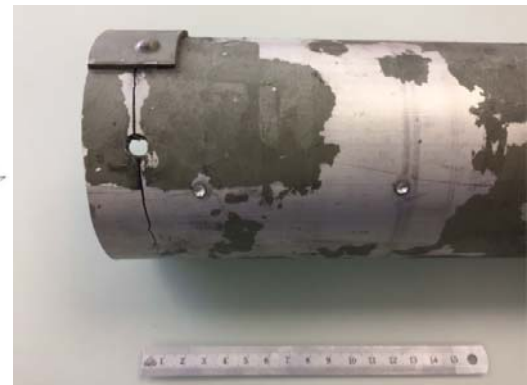
Figure 10 Crack on the disassembled spar

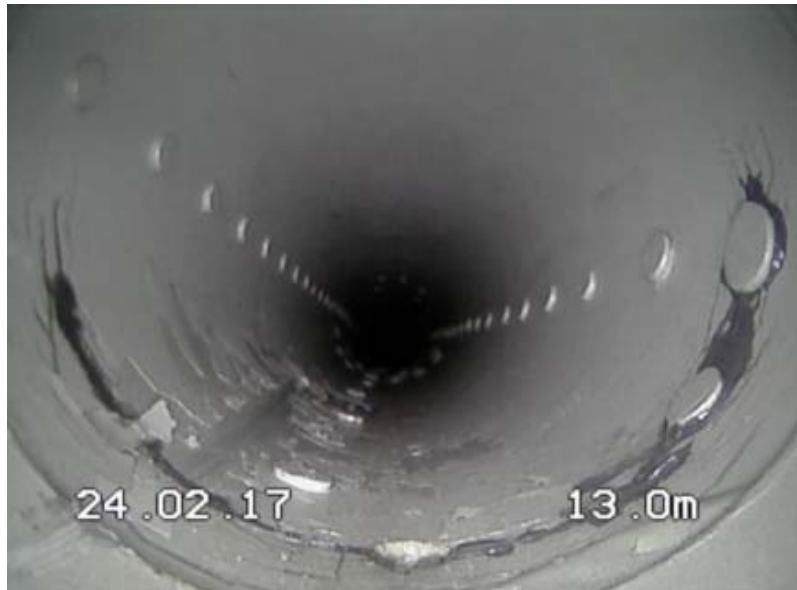
Furthermore, additional borescope inspections (see Figure 11) on all. The possibility of further defect spars was ruled to ensure airworthiness.

Figure 11 Borescope inspections of the cracked spar II

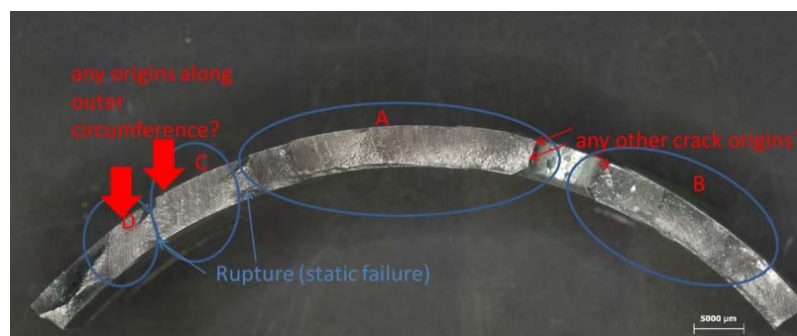
To create a more detailed evaluation of the cracked spar tube, fractographical and material investigations were performed by the ZAV. It was found that the origin of the crack was a drain hole with poor production quality. Furthermore, the material investigations delivered information about the chemical composition and heat treatment of the spars. It was found to be comparable to today used 2014-T3 or 2024-T3. According to the history of the material standards published in the years before world war two, it was not possible to identify properly the material used in the German Ju-52/3m from 1936 (D-AQUI) and the three Swiss aircraft built in 1939. In addition, material parameters for fatigue evaluations or fracture mechanics calculations, such as crack growth life predictions are not available, because the material standard from then shows only classical static properties such as yield, strength and Young's modulus.

Figure 12 Fractographical analysis of the cracked spar tube

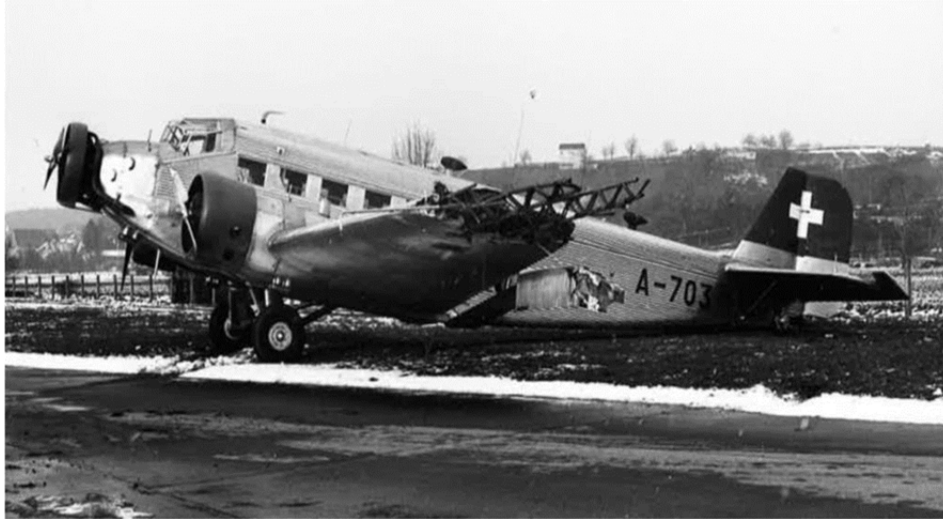
Due to further investigations of the wing structure, the special case of HB-HOP needed to be examined. In 1965 a crash on the ground caused a repair of the whole outer sections on the left wing.

Figure 16 Serious damaged left wing HB-HOP after a crash on the ground (1965)

The new structure is a modification of the original one. While the original construction's spars are tube-profiled, the modified version is based on hat-profiles (see Figure 17). Due to the required re-evaluation of all performed structural repairs, a new static strength verification was needed. The ZAV accomplished this with a conservative approach by a systematic comparison of equivalency for original and modified profiles on all affected wing areas. In addition to this, the used material 2024-T3 for the modification was found to have a higher strength of 7%. By these results, the wing's load capacity and structural integrity could be proven.

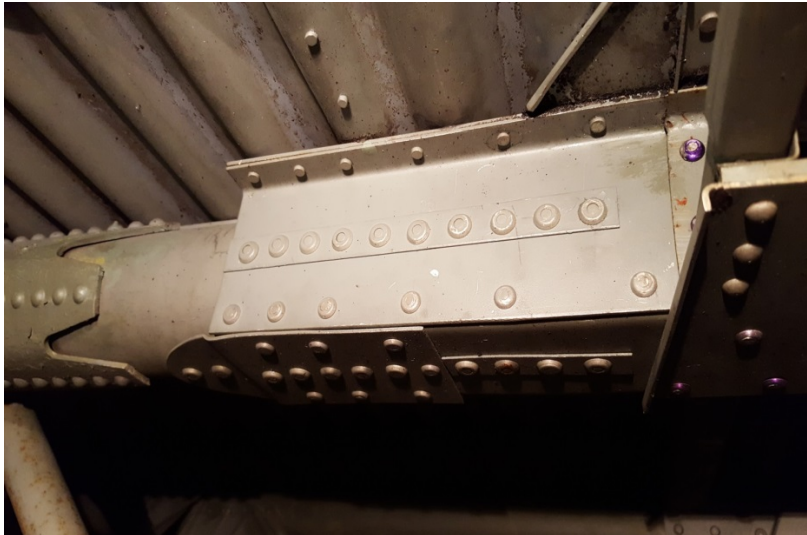
Nevertheless, further investigations are needed to assess the fatigue behaviour of the splices. Using the mentioned calculated aerodynamic loads a more detailed proof of strength for the splices between new and old structures needs to be verified by more detailed calculations and FEA (see Figure 18).

Figure 18 Splice between the modified and original structure

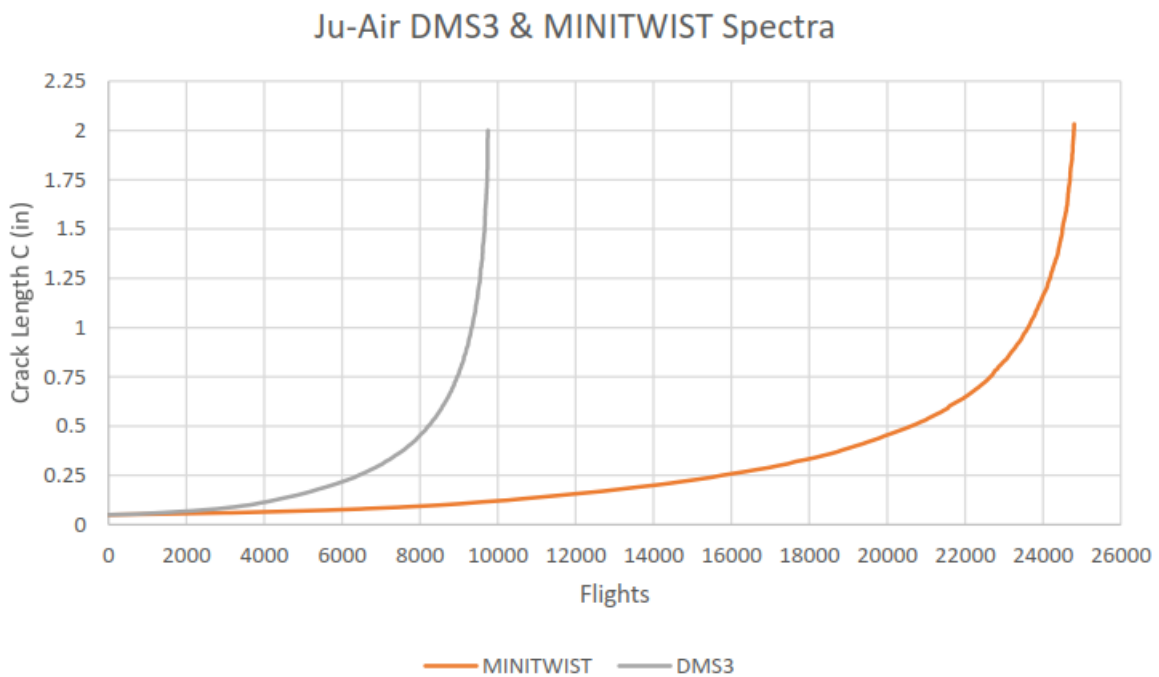
Turning back to the cracked spar, a spar-specific spectrum was used to calculate the crack growth using AFGROW and by that NASGRO equations. In addition to this, it was compared with the MINITWIST. Due to the result of a sharper spectrum, the crack growth was way more accelerated. In Figure 26 you can see the outcome.

Figure 26 Crack Growth comparison between MINITWIST and the sharpest measured strain gauge (DMS3) for spar II

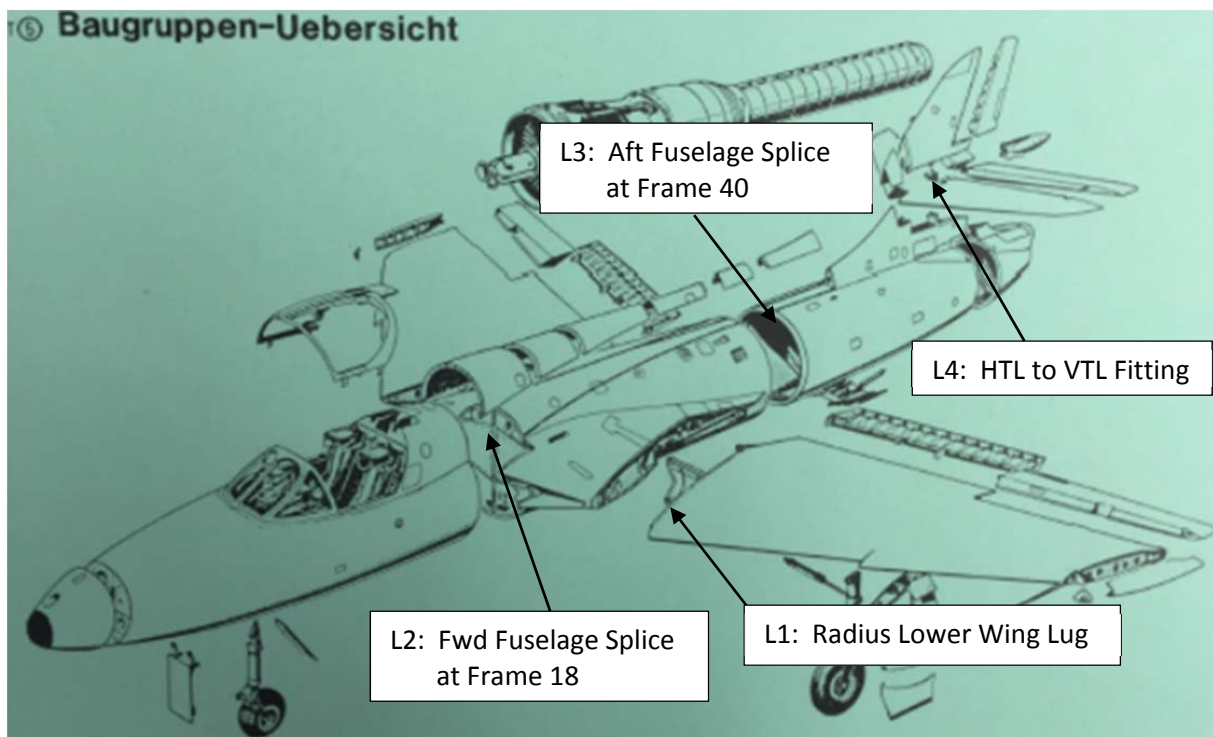
In a second step, additional locations were reviewed from their fatigue criticality point of view. It revealed that four locations had to be considered more in detail (see Figure 27).

Figure 27 Four most critical locations

L1: Radius at Lower Wing Main Spar Lug: The modification (increased radius at the lug) was established and as a result the inspection interval based on the crack growth life is drastically increased.

L2: Forward Fuselage Splice at Frame 18: The cockpit section was separated from the mid-fuselage section in order to perform an in-depth inspection of the four connection points. During this separation process, it was obvious that an additional joint in the upper part of the fuselage transfers a big portion of the fuselage bending moment. Based on this observation it can be concluded that the inspection intervals from the ref. 1 study are slightly conservative.

L3: Aft Fuselage Splice at Frame 40: This splice consists of 15 bolts and thus can be considered as a fail-safe structure. In addition, a thorough inspection of the 15 connection points was performed and no damage was discovered.

L4: Horizontal Tail (HTL) to Vertical Tail (VTL) Fitting: This part was replaced at the time the acquisition of the aircraft by the private organization. Thus, the fatigue life of this part is very long. Based on these results it can be concluded that these four locations can be considered as non-fatigue-critical and therefore additional inspections would not be justified.

Thus, the maintenance concept of the Hunter aircraft operated by the private organization consists of the adjusted maintenance documents mentioned above. No additional inspection is necessary for additional locations.

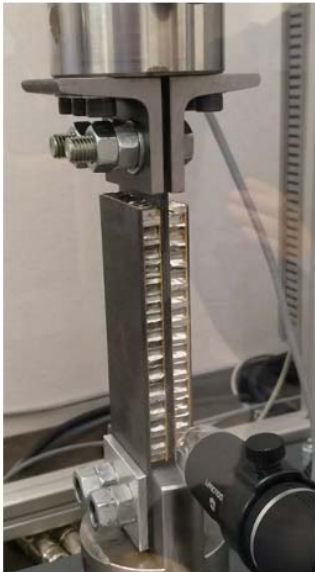
Results: No crack initiation at repaired section observed after 120'000 cycles (70% of ultimate strength)

Fatigue test of sandwich sample under shear loading. Core cells continually checked for cracking, yet no cracks detected near partially filled core cells

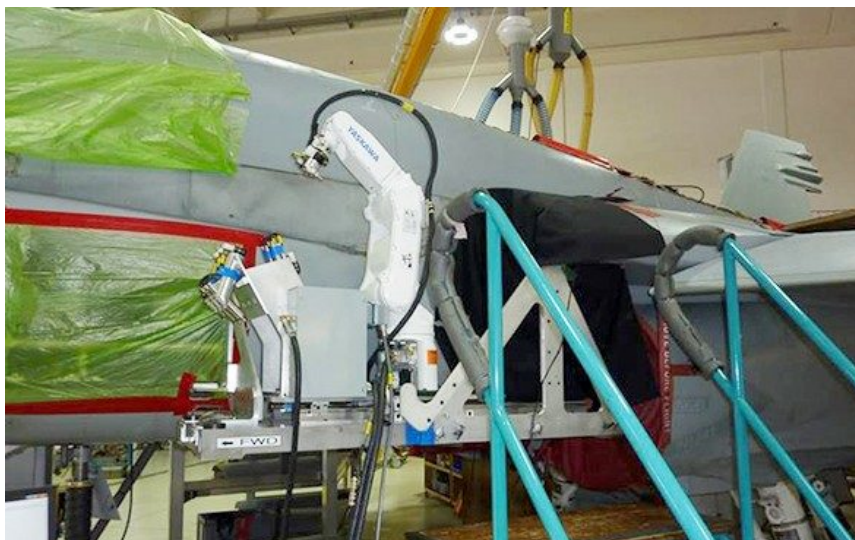
After successful completion of the prototype of the first refurbishment package SRP 2.0 in 2018, the serial implementation of modifications for the fleet is in progress and shall be finished by 2022. The focus of the modifications are blendings of the Center Fuselage formers in the vicinity of the Leading Edge Extension, replacements of fracture and maintenance critical parts with an improved design, such as the bootstrap and speed brake longeron, as well as the modification of other maintenance critical parts, such as several locations of the lower outboard longeron in the aft fuselage.

Figure 28 Blending of two critical locations on Former 395 with the help of a robot

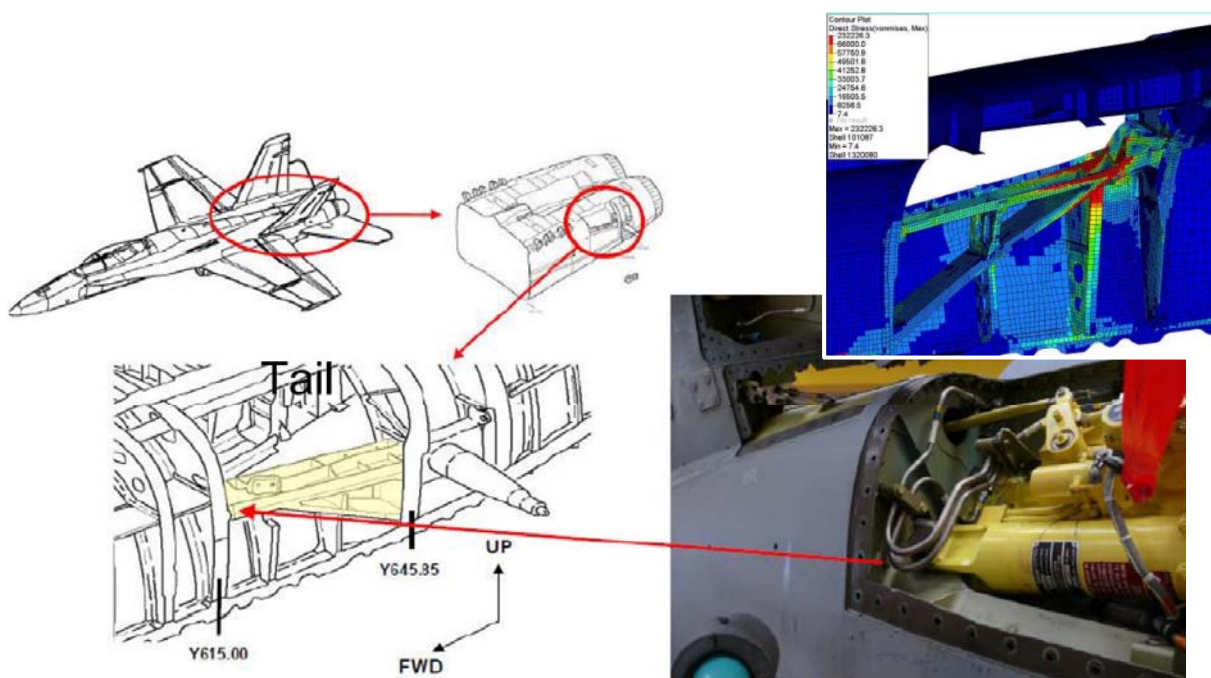
Figure 29 Horizontal stabilizer bootstrap replacement by modified part

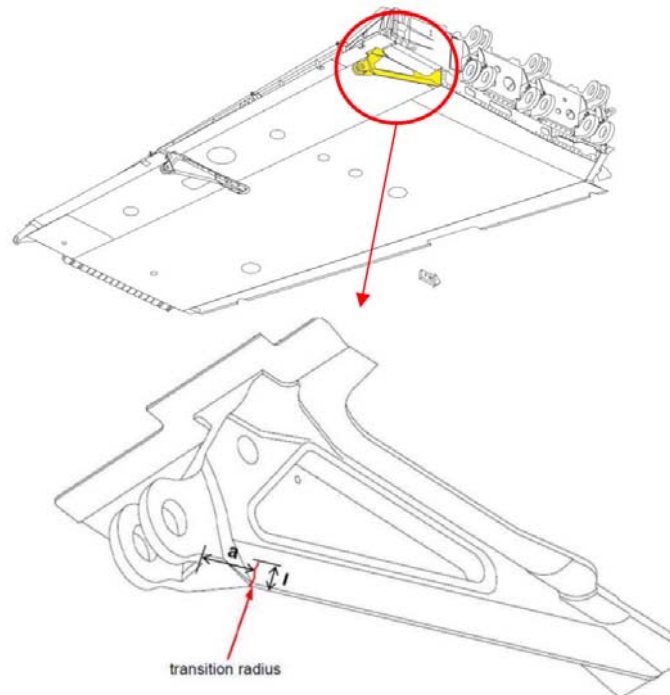
An exemplary issue to ensure flight safety before SRP 2 is the inner wing inboard Trailing Edge Flap (TEF) Hinge for which a recurring inspection program and a robotic reblending of three zones is underway to reduce the stress concentration. As in-service cracking occurred on several parts and locations, multiple strategies to achieve full life solutions are required besides the development of the actual modification. Another example of a location at which cracks occurred in the inspections prior to the SRP 2 is the lower outboard longeron, where the installation of the planned modification has been performed as a repair. Hence an advanced modification will be developed to achieve a full life.

Figure 30 Inner wing inboard Trailing Edge Flap Hinge modification
